[Redacted] KY

Prepared by:  
Armor Home  
Inspections

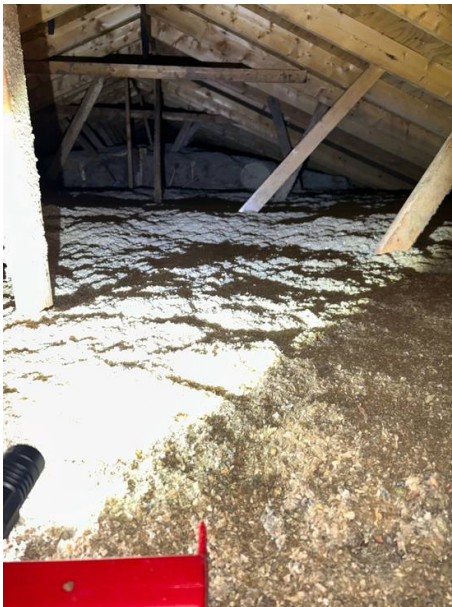
The (Cut Outs for previously installed ridge ventilation were not sealed when the metal roof was installed.

Major Defect Noted- (a condition of a system or component that renders it non-working, non-performing, non-functioning or unsafe, and requires a professional contractor to evaluate further and repair, correct or replace.)

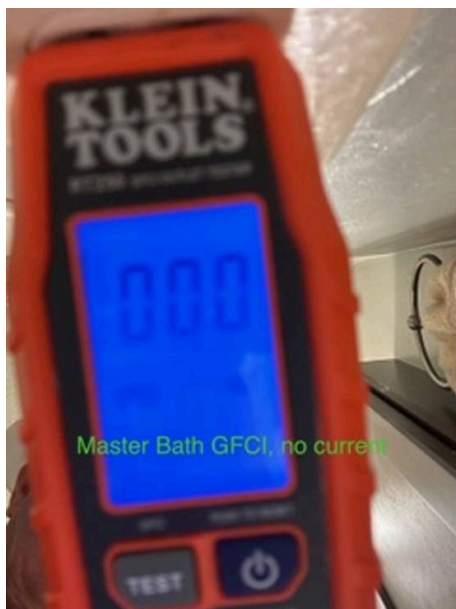
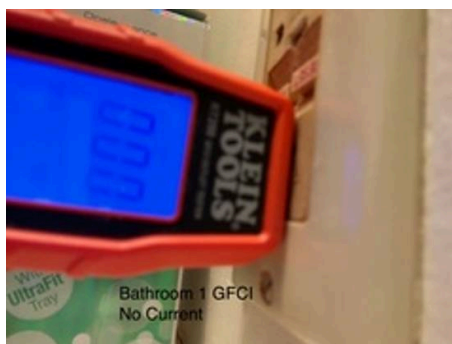
Neither bathroom GFCI operates or has current. The GFCI in bath #1 test and reset buttons do not operate. It is likely that both outlets are on the same circuit. A qualified professional should inspect and repair/replace the outlets.

Major Defect Noted- a condition of the GFCIs in the bathroom renders them non-working, non-performing, non-functioning or unsafe and requires a professional contractor to evaluate further and repair, correct or replace.

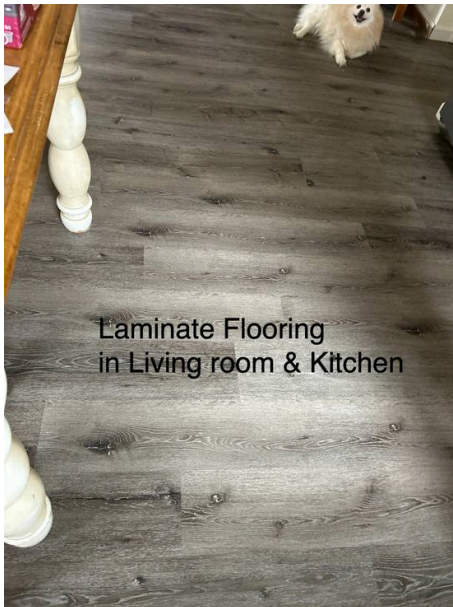
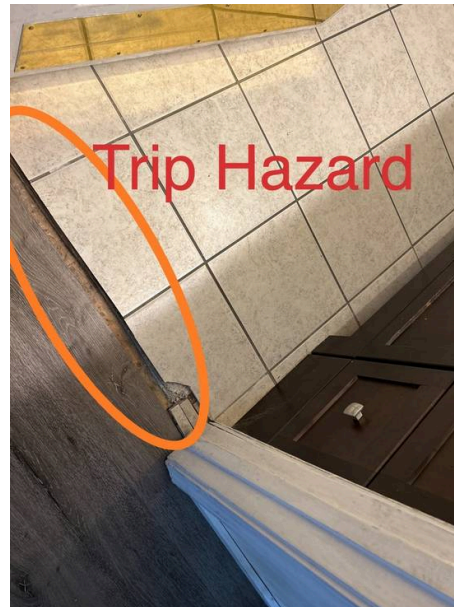
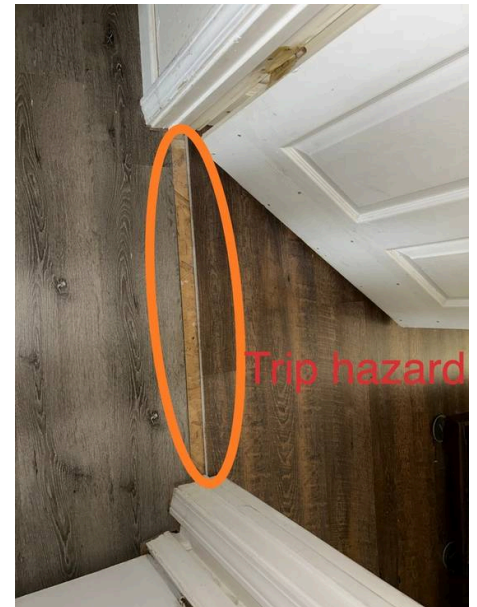
In the doorways to the master bathroom and back spare bedroom, the floors have gaps and uneven heights as it transitions between types of flooring systems. This is a trip hazard. Recommend that a professional or the homeowner install floor transition strips or "T-caps"

Major Defect Noted- The gaps between flooring systems are a trip hazard and require a professional contractor or the homeowner to evaluate further and repair, correct or replace.

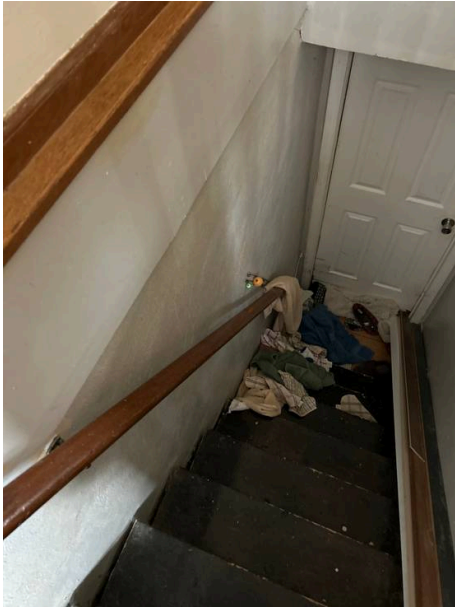
Loose railing was noted at stairs and is a safety issue that should be corrected.

Major Defect Noted- The loose handrail is unsafe, and requires a professional contractor or the homeowner to evaluate further and repair, correct or replace.

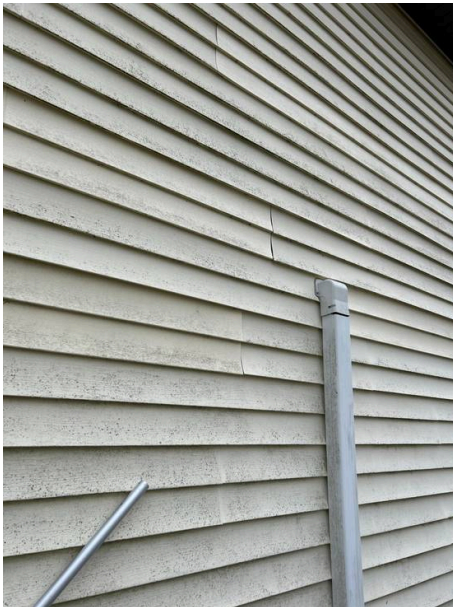
Cosmetic Defect Noted - superficial flaw or blemish in the appearance of a system or component that does not interfere with its safety or functionality.

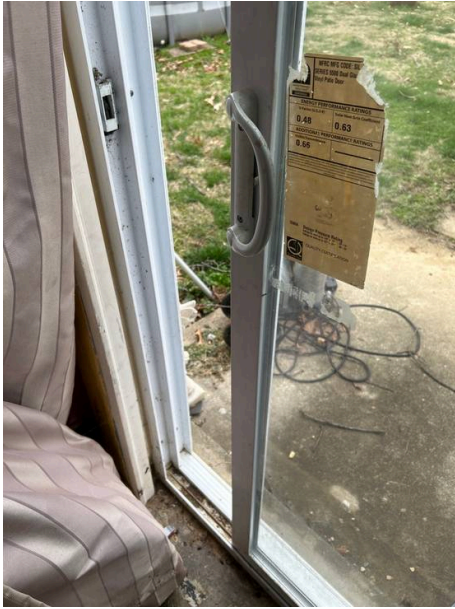
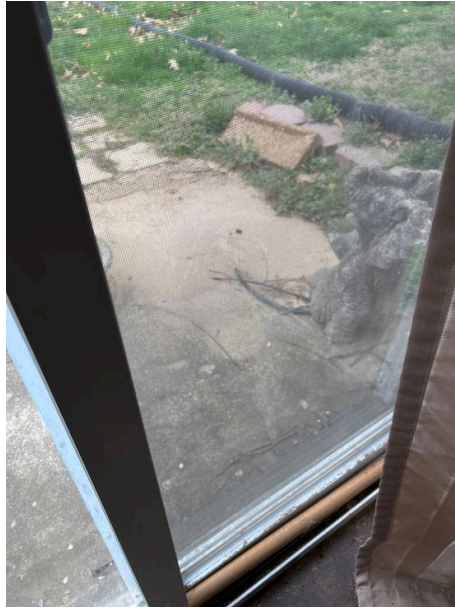
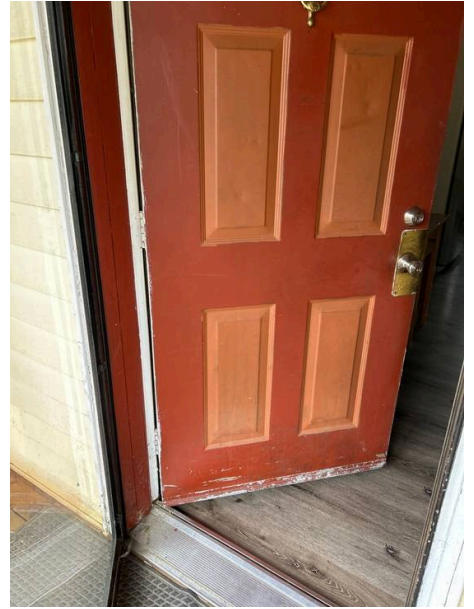
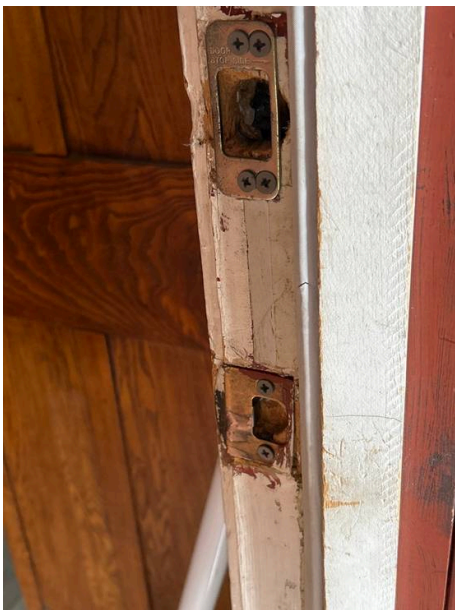
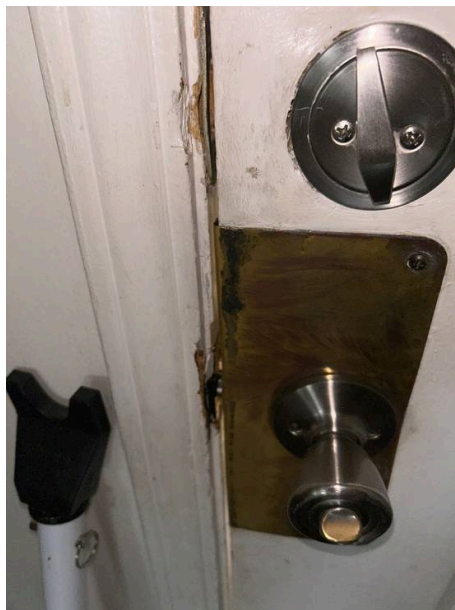
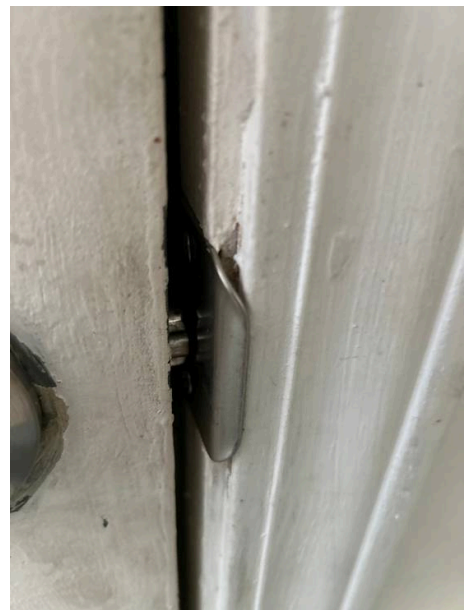
Neither main floor exterior door latches properly. Only the deadbolt secures the doors. Recommend qualified handyman adjust the strike plate and/or lock.

Minor Defect Noted - a condition of a system or component that renders it non-working, non-performing, or non-functioning, and may be repaired, corrected or replaced by a professional contractor or the homeowner.

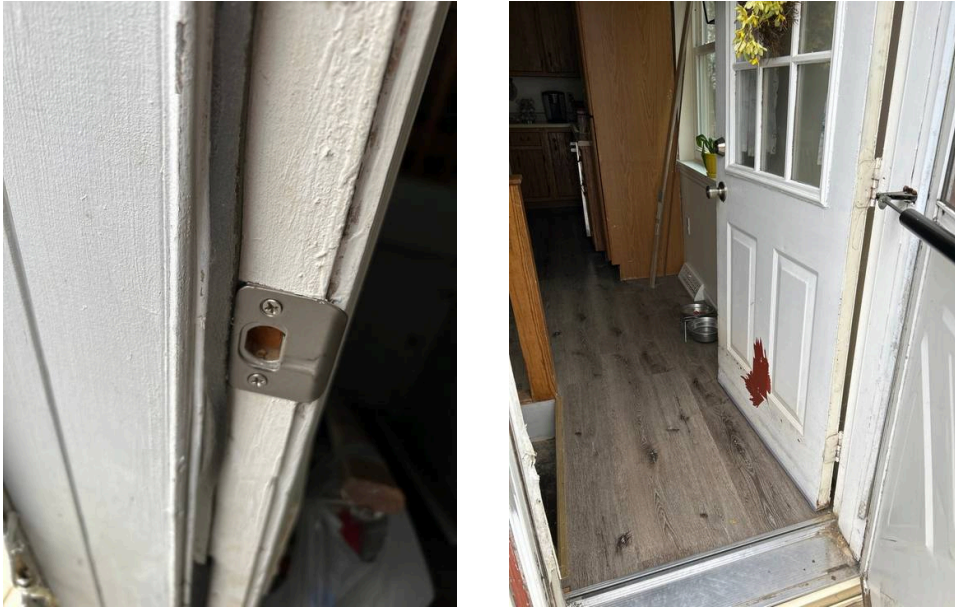
Evidence of standing water was observed on the concrete pad outside of the slider door, which could indicate poor drainage and/or grading. The slider door is only 2-3" above the pad. Water standing in this location could deteriorate the concrete and/or the frame of the slider door.

Grading slopes towards the home near the slider door. This could lead to water intrusion and foundation issues. Recommend qualified landscaper or foundation contractor regrade so water flows away from home.

Recommend monitor and/or having a landscaper correct.

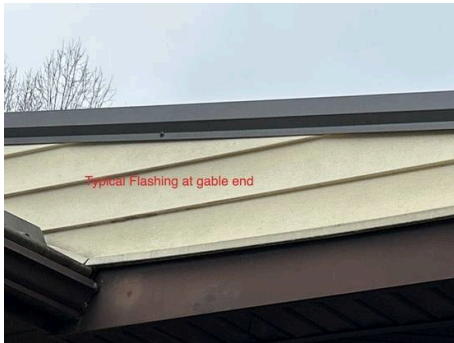
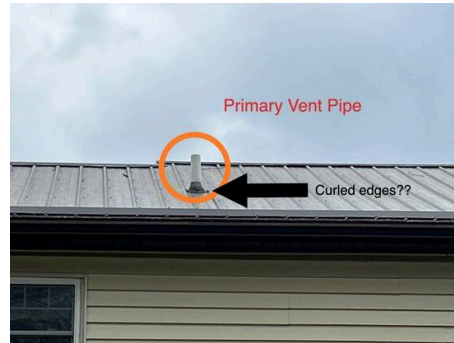
I was only able to inspect this portion with binoculars. I noted through them that the edges of the flashing appeared to be "curled upward." If water can get through at this point, significant damage to the roof structure could occur. A professional should inspect this.

Flashings observed to be loose or separated, which can lead to water intrusion and/or mold. Recommend a qualified roofing contractor repair.

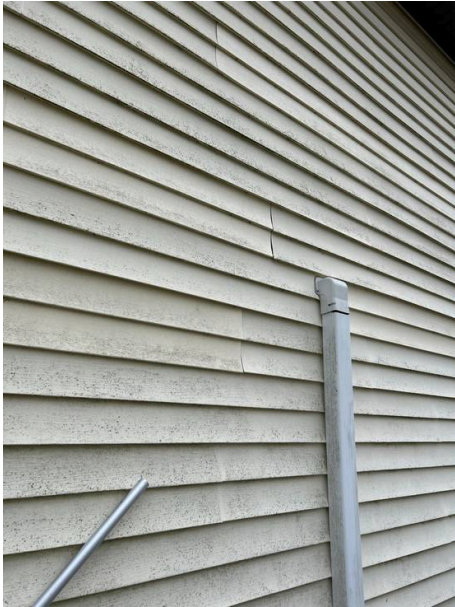
Cosmetic Defect Noted - superficial flaw or blemish in the appearance of a system or component that does not interfere with its safety or functionality.

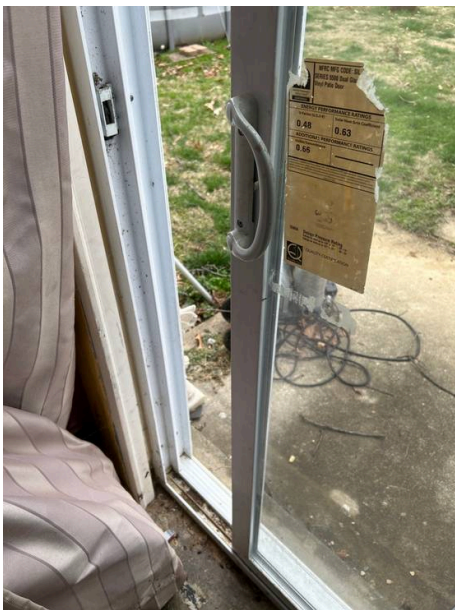
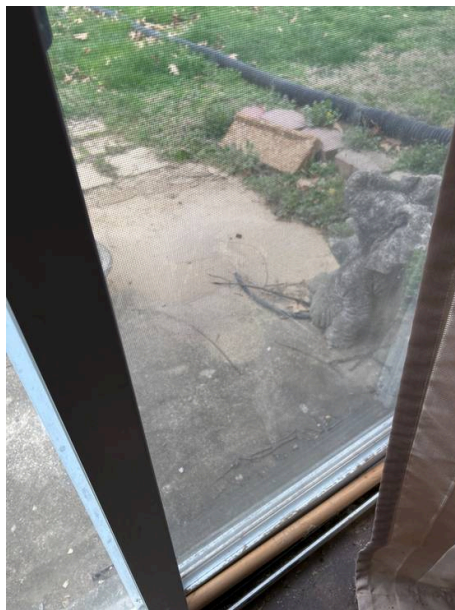
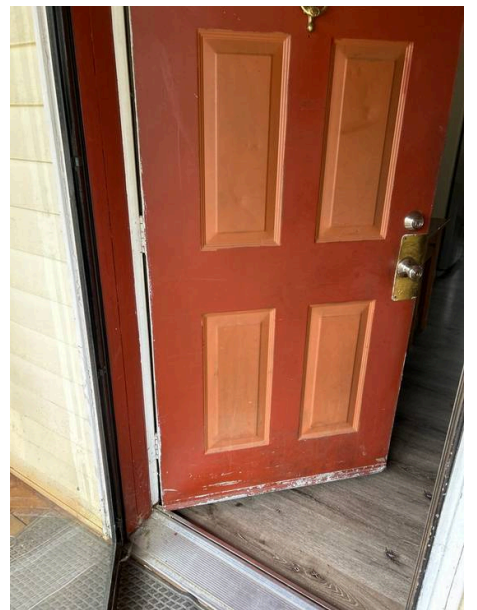
Neither main floor exterior door latches properly. Only the deadbolt secures the doors. Recommend qualified handyman adjust the strike plate and/or lock.

Minor Defect Noted - a condition of a system or component that renders it non-working, non-performing, or non-functioning, and may be repaired, corrected or replaced by a professional contractor or the homeowner.

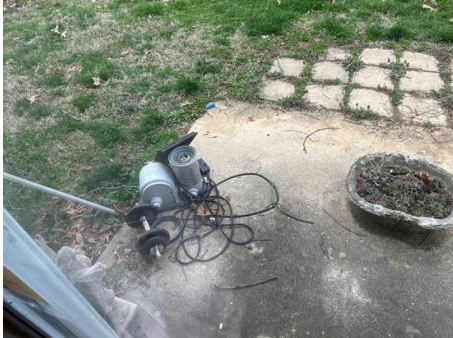
Grading slopes towards the home near the slider door. This could lead to water intrusion and foundation issues. Recommend qualified landscaper or foundation contractor regrade so water flows away from home.

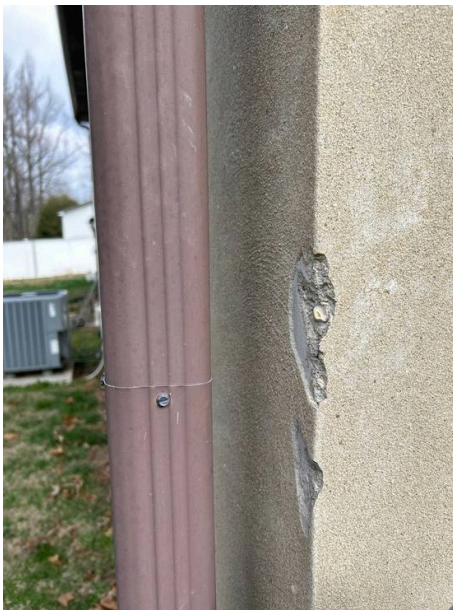
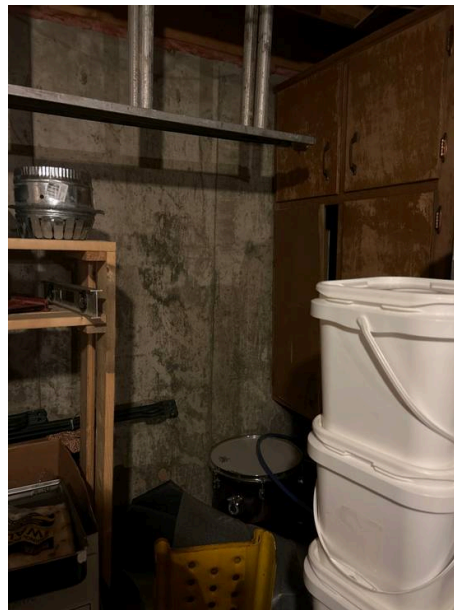
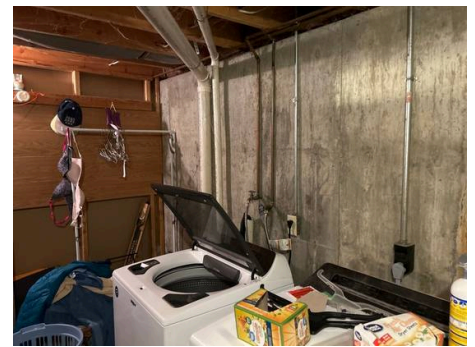
Staining on interior foundation walls does not appear to be moisture related. Minor spalling on the left-rear corner was noted.

Cosmetic Defect Noted - The superficial flaw or blemish in the appearance of the interior foundation walls and the spalling on the exterior does not interfere with its safety or functionality.

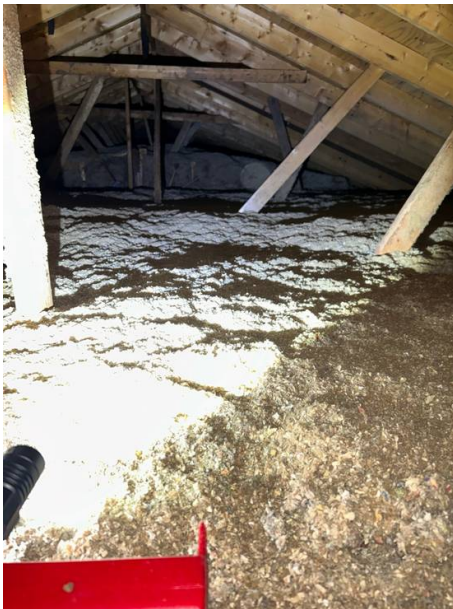
(Cut Outs for previously installed ridge ventilation were not sealed when the metal roof was installed.

Major Defect Noted- (a condition of a system or component that renders it non-working, non-performing, non-functioning or unsafe, and requires a professional contractor to evaluate further and repair, correct or replace.)

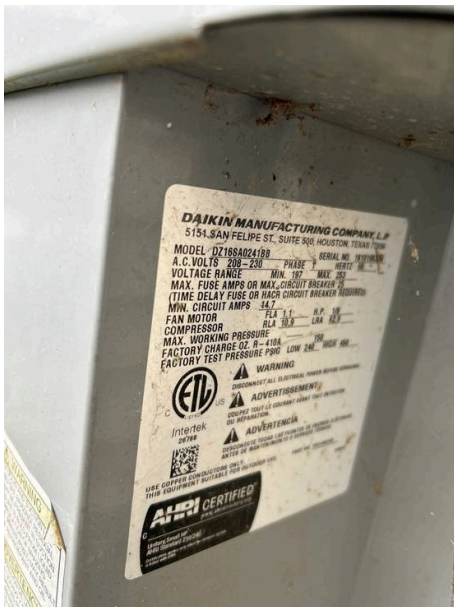
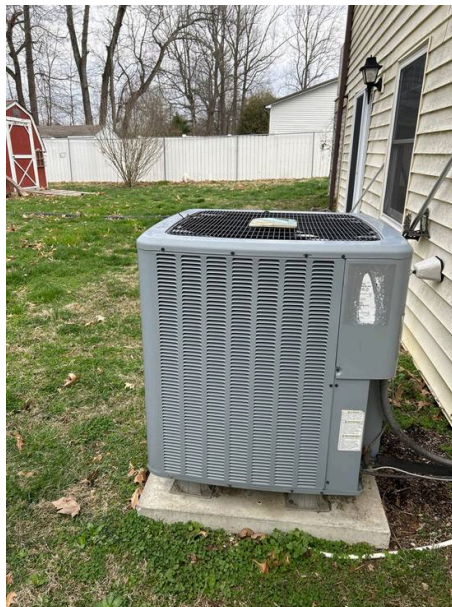
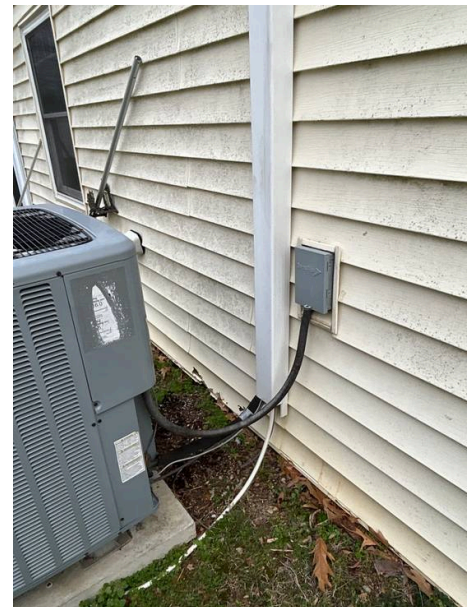
Daikin Heat Pump Manufactured 2016

The A/C unit was not tested due to low outdoor temperature. This may cause damage the unit.

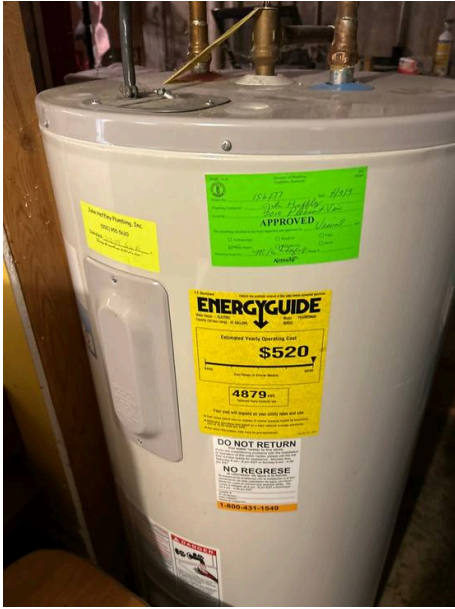
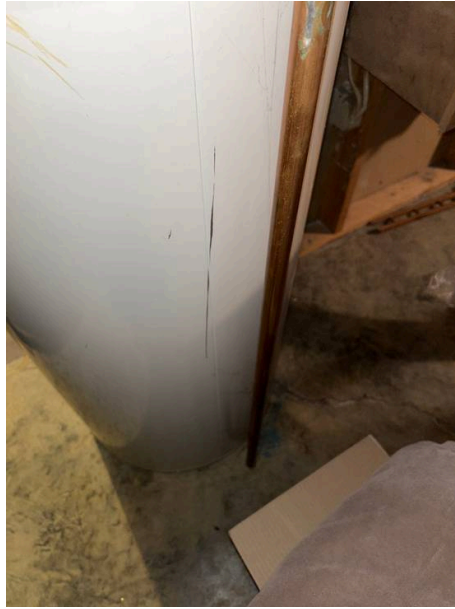
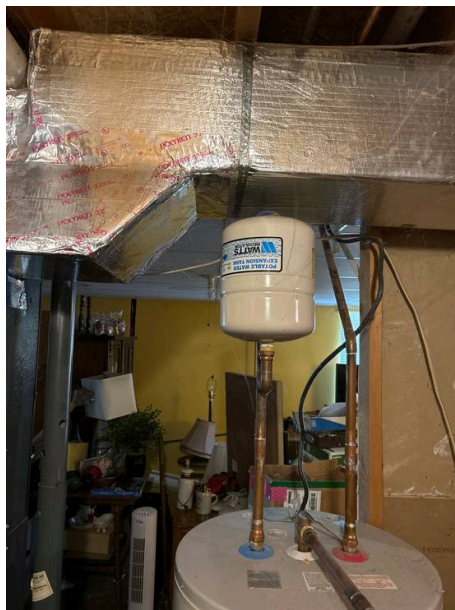
I recommend flushing servicing your water heater tank annually for optimal performance. Water temperature should be set to at least 120 degrees F to kill microbes and no higher than 130 degrees F to prevent scalding.

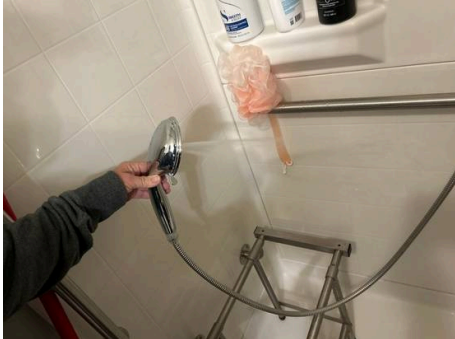
Hand Held Shower Head Needs replaced. Falls out from holders.

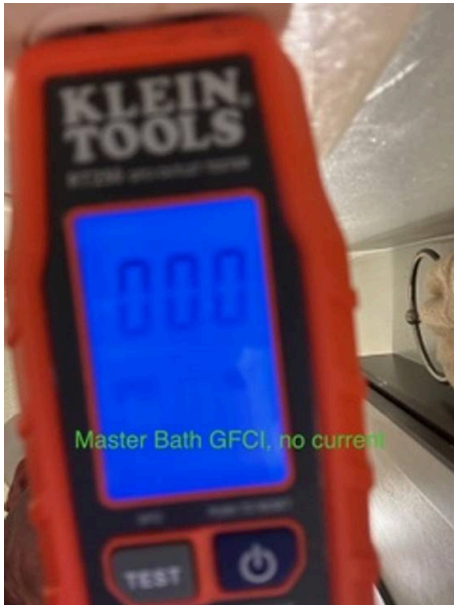
Neither bathroom GFCI operates or has current. The GFCI in bath #1 test and reset buttons do not operate. It is likely that both outlets are on the same circuit. A qualified professional should inspect and repair/replace the outlets.

Major Defect Noted- a condition of the GFCIs in the bathroom renders them non-working, non-performing, non-functioning or unsafe and requires a professional contractor to evaluate further and repair, correct or replace.

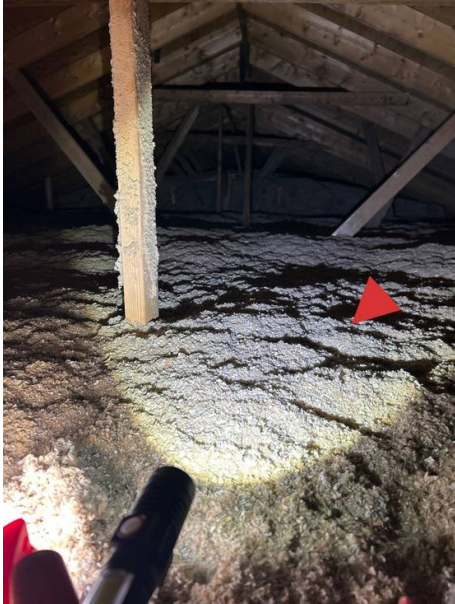
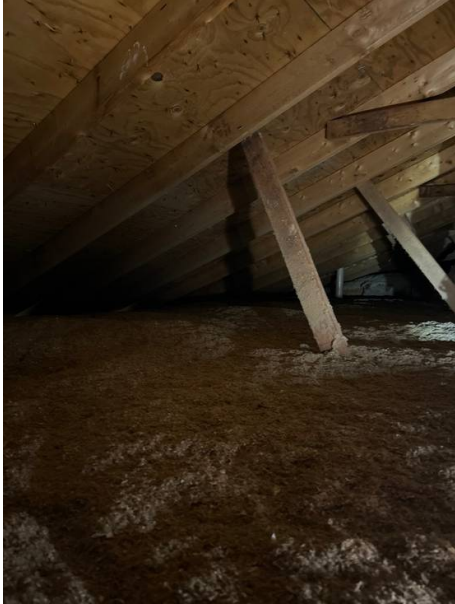
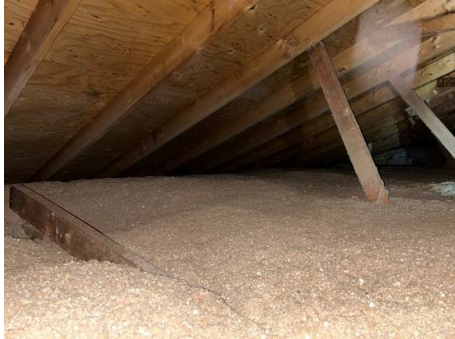
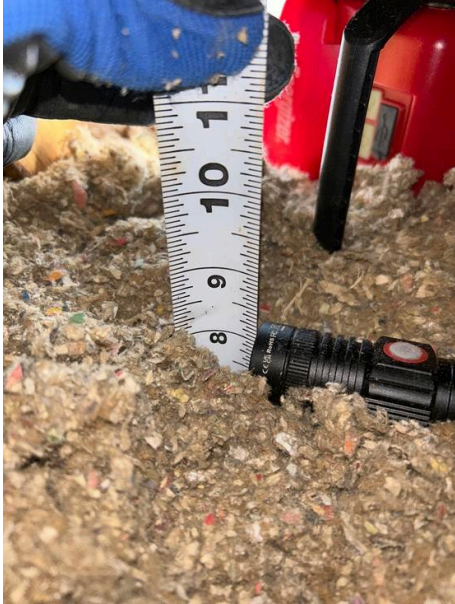
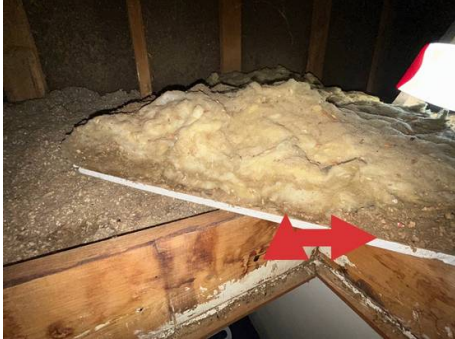
Loose-fill

Could not access. Visual inspection from hatch only.

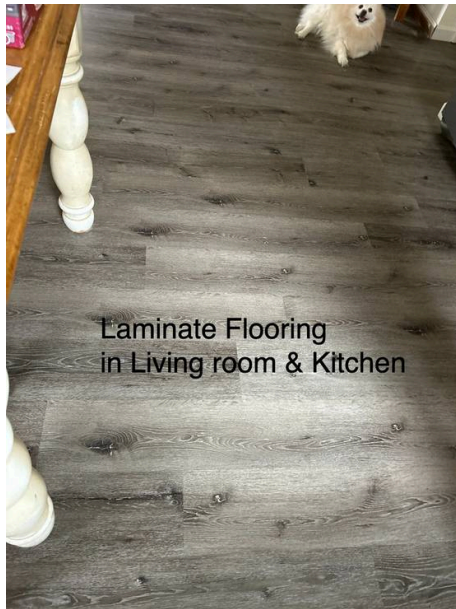
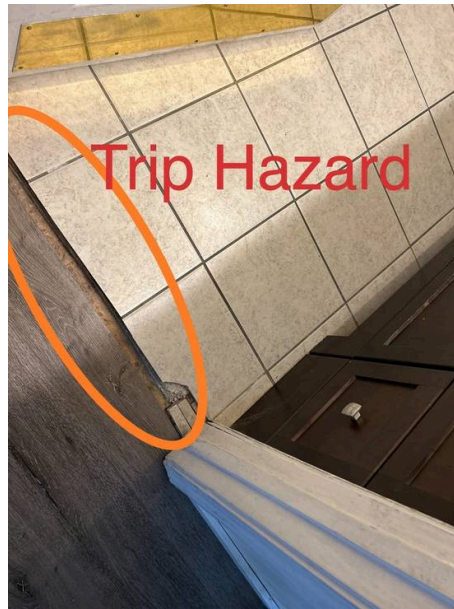
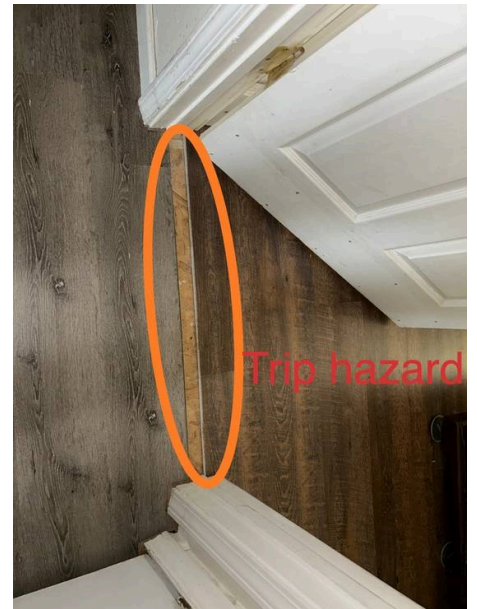
In the doorways to the master bathroom and back spare bedroom, the floors have gaps and uneven heights as it transitions between types of flooring systems. This is a trip hazard. Recommend that a professional or the homeowner install floor transition strips or "T-caps"

Major Defect Noted- The gaps between flooring systems are a trip hazard and require a professional contractor or the homeowner to evaluate further and repair, correct or replace.

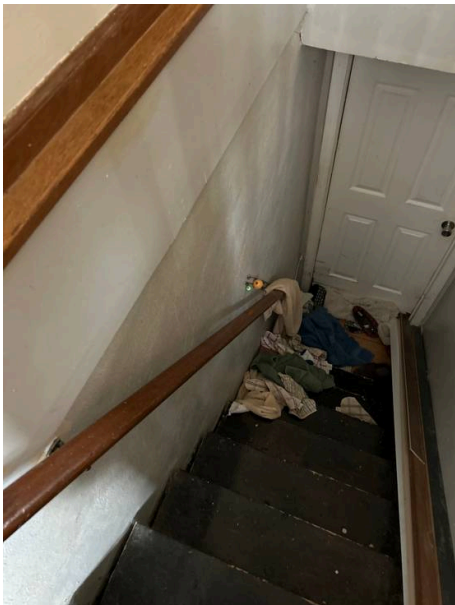
corrected.

Loose railing was noted at stairs and is a safety issue that should be
